SOIL EROSION MAP

Doña Josefa Watershed

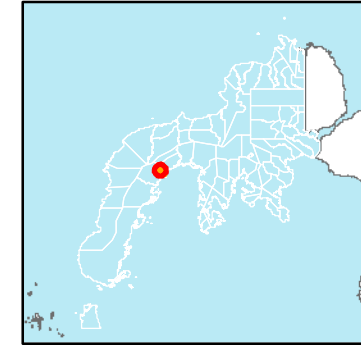
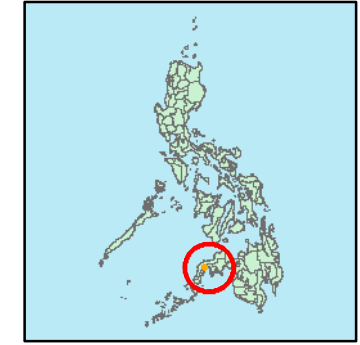
EROSION SUSCEPTIBILITY	AREA
No apparent erosion	165.13
Slight erosion	1,014.96
Moderate erosion	1,352.91
TOTAL	2,533.00

- No apparent erosion
- Slight erosion
- Moderate erosion

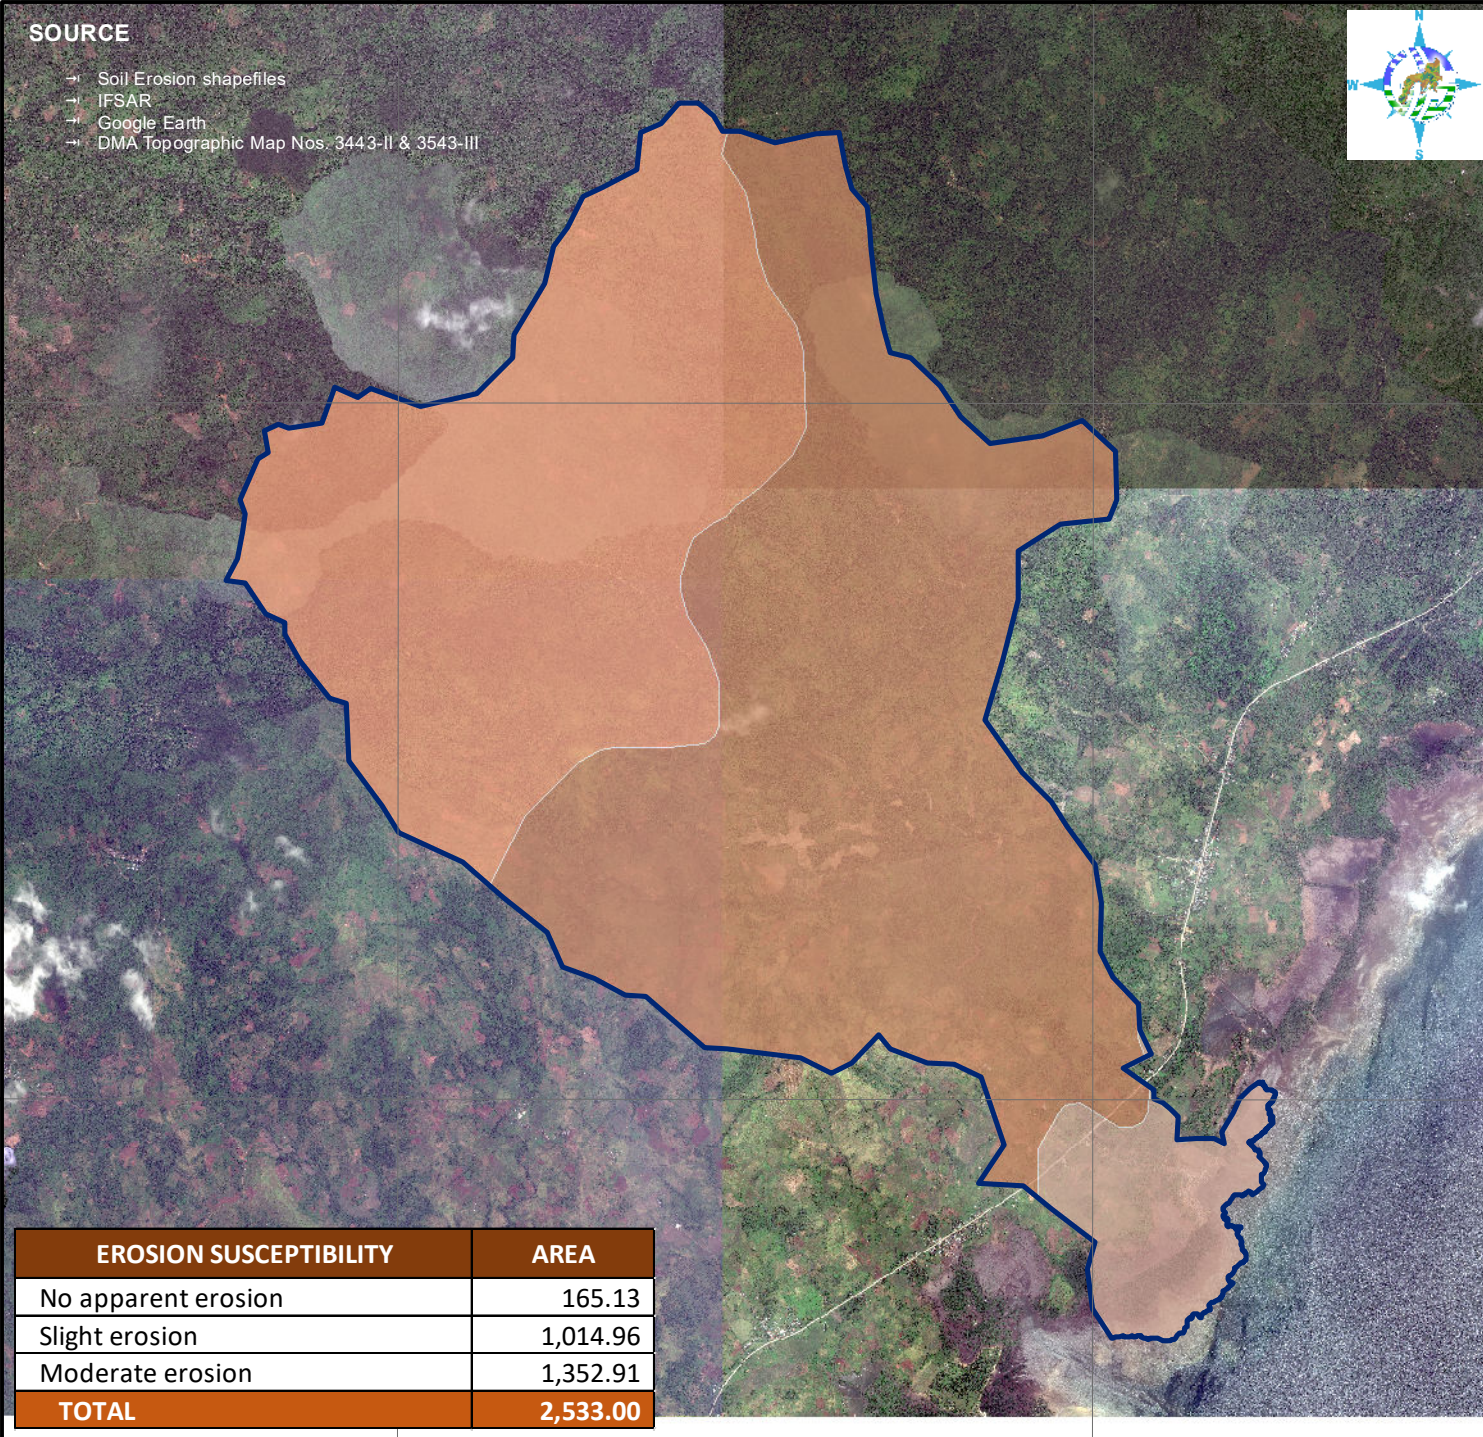
SOIL EROSION CATEGORY
